Case History for Outdoor Storage

HT 365 Preservation Coating

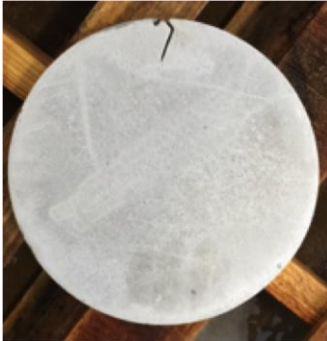
- Customer needed to remove corrosion from a 2-inch hot rolled steel plate, laser cut in 12-inch diameter circular sample with visible rust and mill scale (“Sample A”).
- Customer applied a complementary product to remove all rust to the molecular level as seen in the following picture.

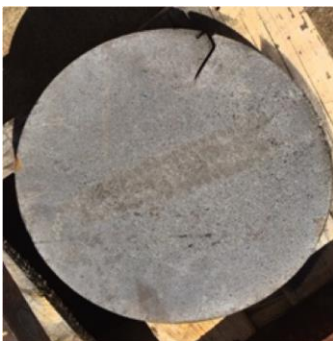
Date of observation: May 1, 2015 (below)

- **HT 365** was applied to one side of Sample A and its entire edge. The other side of Sample A was left untreated.
- Sample A was stored outside in an uncovered area on a wooden pallet on its edge to expose both sides.
- After 63 days, Sample A was observed for the first time and did not show any signs of rust on the side that was treated with **HT 365**.
- Date of application: February 26, 2015

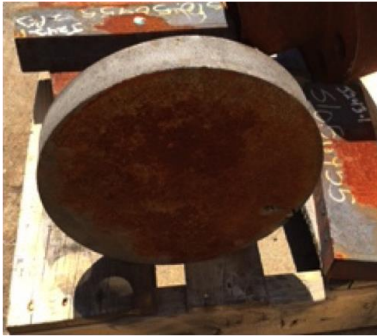
- After 90 days, Sample A was observed for the second time and had just begun to show signs of rust bloom on the sides that were treated with **HT**

365. It is estimated on the basis of the light corrosion that was observed that **HT 365** began to lose its effectiveness after 80 to 85 days.

- During the months of March and April, temperatures ranged from 35 to 90 degrees Fahrenheit. Several heavy rain storms were documented during the month of April, 2015
- The entire edge of Sample A that was also treated with **HT 365** remained rust free.
- Now, if the Customer needs to remove **HT 365** for any reason, they may do so by pressure washing the metal with **HoldTight 102** diluted at 100: 1 water to **HoldTight 102**, rather than costly hand cleaning, as required by their current product in use.

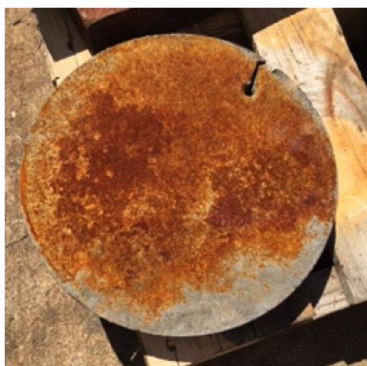
- On the side of Sample A that was not treated with **HT 365**, heavy rusting occurred.
- The applicator had started to paint this side with **HT 365** before being stopped (so that there would be a control side).
- The area where **HT 365** had been applied can be seen on the bottom sliver of Sample A where it is rust-free, the rest of that side is heavily corroded.
